# Safety Inspection Report

Annual Inspection

## Ewshot Recreation Ground

26 May 2026

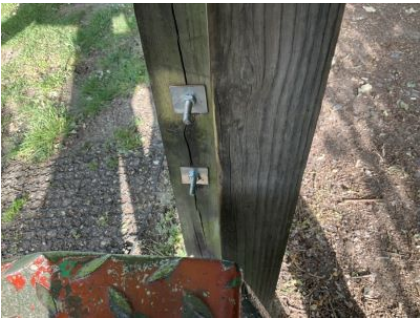
| Description |
|---|
| Projecting bolt thread. |
| By side of large slide. |

| Description |
|---|
| Cut off and file down to remove sharp edges or use the correct length of bolt. |

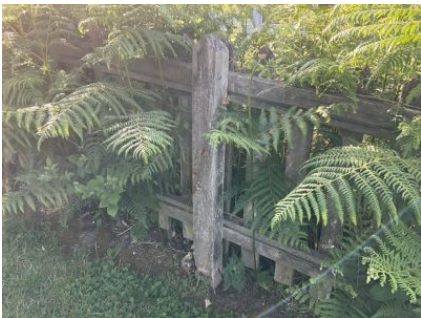
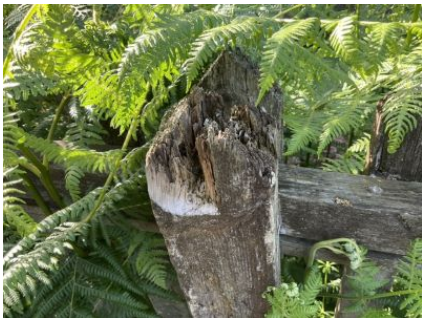
Timber is decayed.

Replace affected parts.

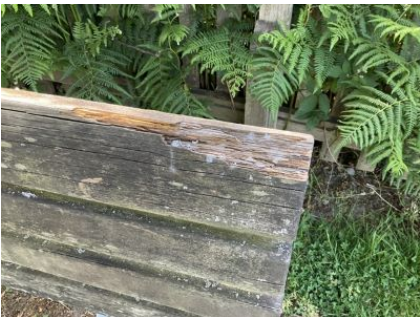
Timber is decayed.

Check on a routine basis.

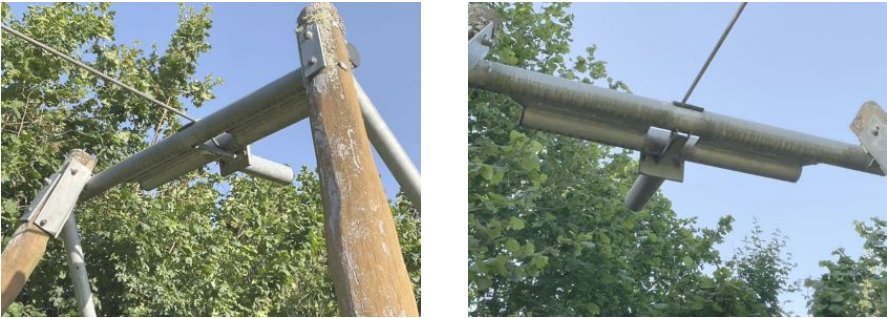
Cables have been known to fail under load due to wear and corrosion. This is generally where the cable enters into a tube, top bar, sleeve or similar, where the wire is in contact and wears and frays over time, but can happen anywhere on the cable. It is important to inspect any hidden parts at least annually. Damaged cables require replacement. This cannot be determined during an annual inspection, and is excluded from our inspection. This can lead to a high risk if no action is taken. Refer to the manufacturer's instructions to ensure the correct check is carried out.

Conduct an appropriate dismantling inspection.

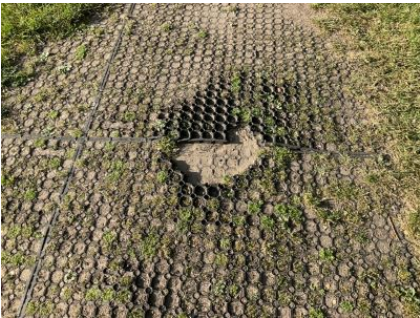
Surface needs repair.

Repair.

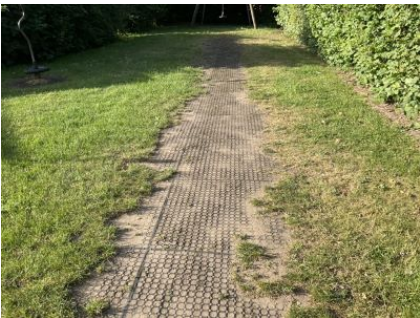
Surface is wearing.

Monitor for significant deterioration and rectify when necessary.

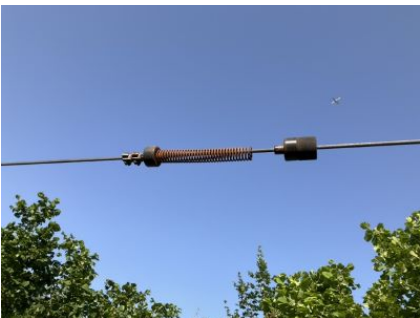
The buffer stop and spring have separated.

Repair.

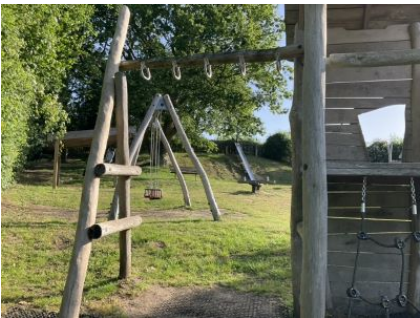
Overhead ladders and rings provide significant play value and benefits to children, and with it the risk of falling. Ensuring the surface remains in good condition will help to keep the correct balance between benefits and risk.

The protective surface under all bars and rings must be kept in good condition.

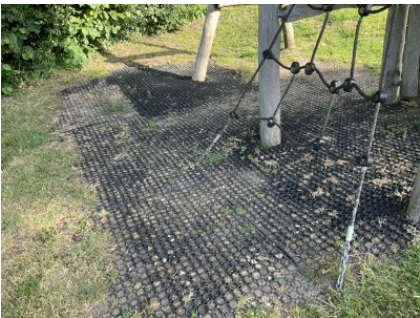
Surface is wearing.

Monitor for significant deterioration and rectify when necessary.

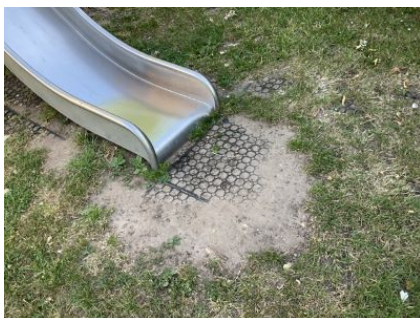
Surface is wearing.

Monitor for significant deterioration and rectify when necessary.

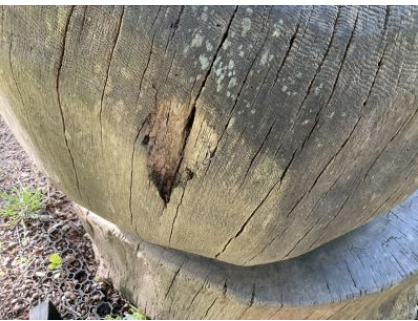
Timber is decayed.

Check on a routine basis.

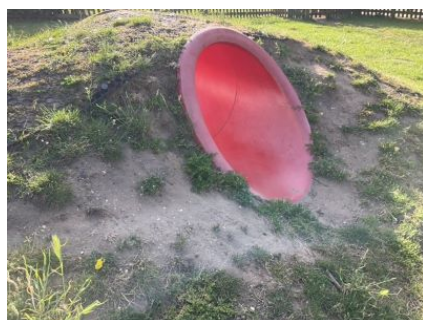
Surface is wearing.

Monitor for significant deterioration and rectify when necessary.

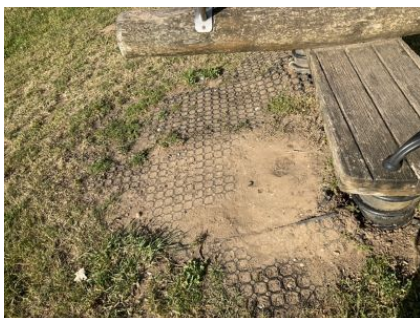
Surface is wearing.

Monitor for significant deterioration and rectify when necessary.

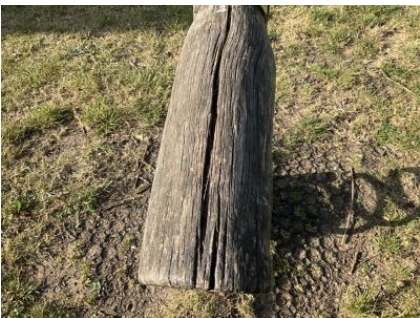
| Description | Tasks | Risk score |
|---|---|---|
| There are natural splits / shakes in the timbers. | Monitor and sand back any splintered edges as required. | 4 |

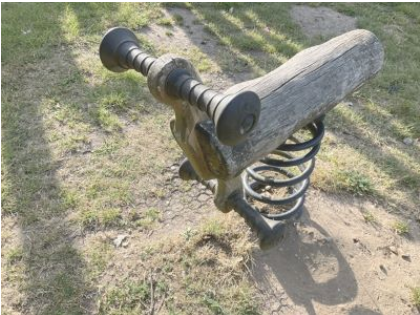
Fixtures loose or missing.

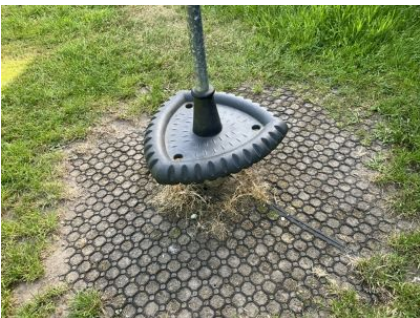
There is wear in the bearings.

Monitor and replace when necessary.

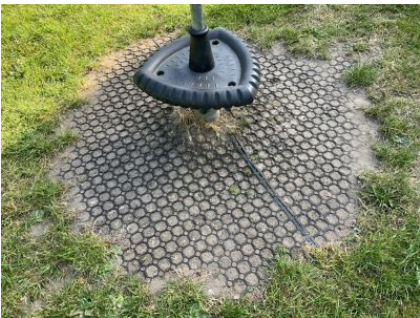
Surface is wearing.

Monitor for significant deterioration and rectify when necessary.

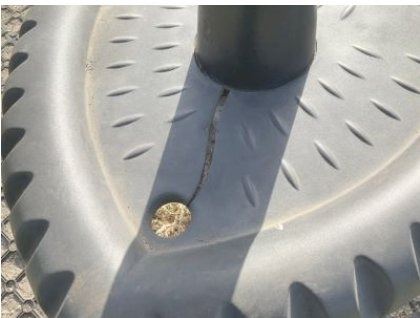
Item is cracked.

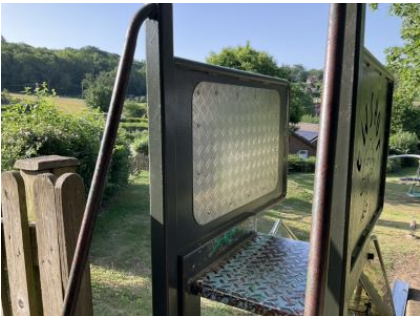
| Description | Tasks | Risk score |
|---|---|---|
| The barrier height is below the minimum of 700 mm, when measured from the surface of the platform, stairs or ramp. | The unit was installed prior to the publication of the current standards. There is no requirement to make retrospective changes. | 4 |

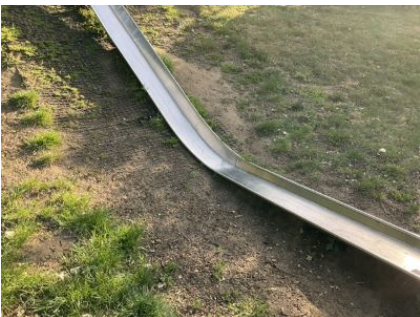
Surface is wearing.

Monitor for significant deterioration and rectify when necessary.

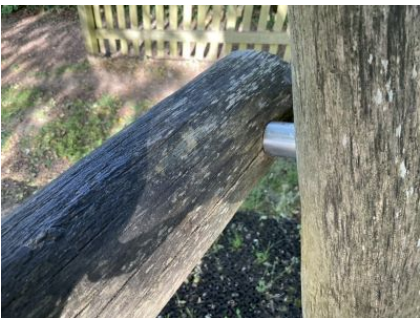
Fixtures loose or missing.

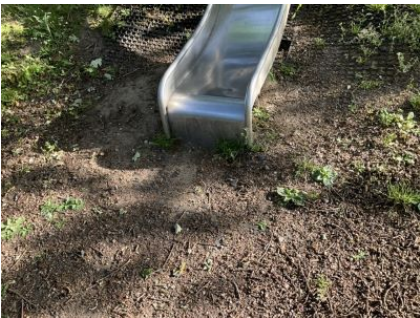
Surface is wearing.

Monitor for significant deterioration and rectify when necessary.

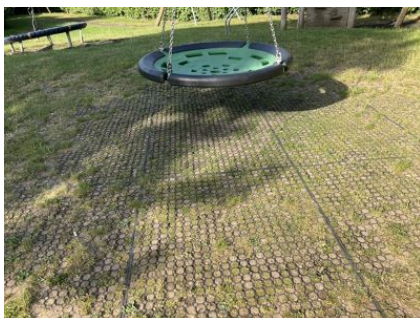
Surface is wearing.

Monitor for significant deterioration and rectify when necessary.

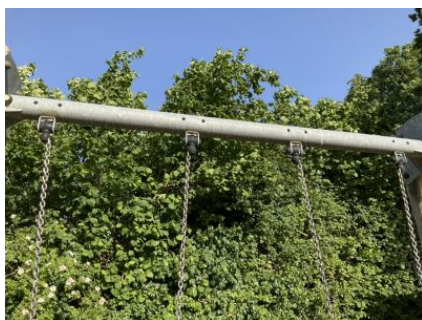
The covers should be removed from the fitting at the top of the chain annually and the shackle bolt should be checked for wear. Check the security of the fittings too.

Replace at 70% of original diameter (30% wear).

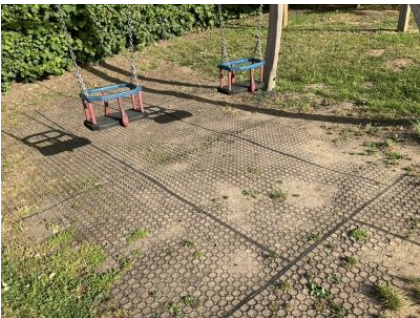
Surface is wearing.

Monitor for significant deterioration and rectify when necessary.

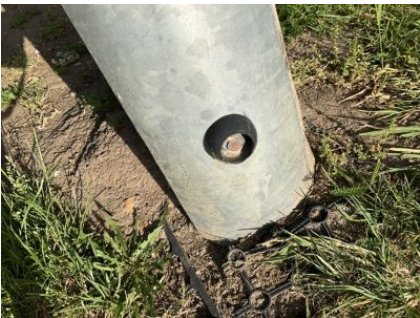
Cap missing.

Replace.

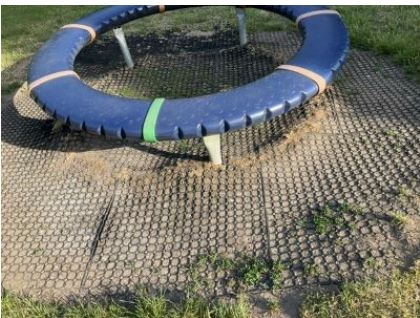
Surface is wearing.

Monitor for significant deterioration and rectify when necessary.
